**DEPARTMENT OF TRANSPORTATION****DIVISION OF ENGINEERING SERVICES**

Contract #: 04-0120F4Cty: SF/ALA Rte: 80 PM: 13.2/13.9File #: 1.28**WELDING INSPECTION REPORT****Resident Engineer:**Siegenthaler, Peter**Address:** 333 Burma Road**City:** Oakland, CA 94607**Report No:** WIR-021720**Date Inspected:** 10-Mar-2011**Project Name:** SAS Superstructure**OSM Arrival Time:** 700**Prime Contractor:** American Bridge/Fluor Enterprises, a JV**OSM Departure Time:** 1730**Contractor:** American Bridge/Fluor Enterprises, a JV**Location:** Job Site**CWI Name:** Gary Ersham and Steve Jensen**CWI Present:** Yes No**Inspected CWI report:** Yes No N/A**Rod Oven in Use:** Yes No N/A**Electrode to specification:** Yes No N/A**Weld Procedures Followed:** Yes No N/A**Qualified Welders:** Yes No N/A**Verified Joint Fit-up:** Yes No N/A**Approved Drawings:** Yes No N/A**Approved WPS:** Yes No N/A**Delayed / Cancelled:** Yes No N/A**Bridge No:** 34-0006**Component:** Orthotropic Box Girder**Summary of Items Observed:**

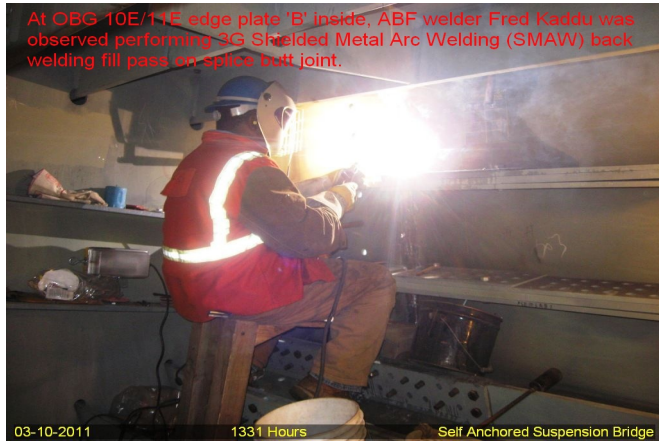
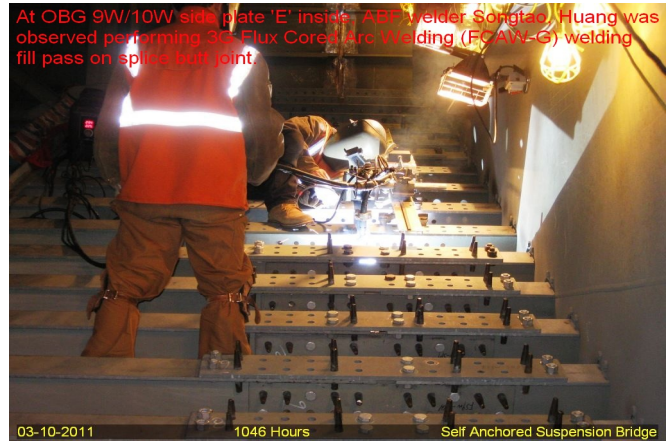
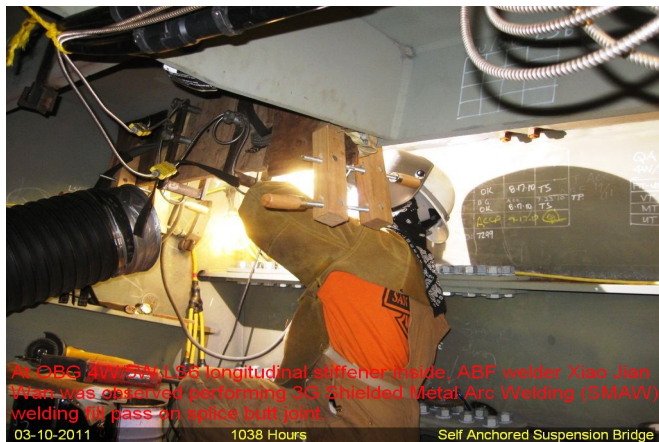
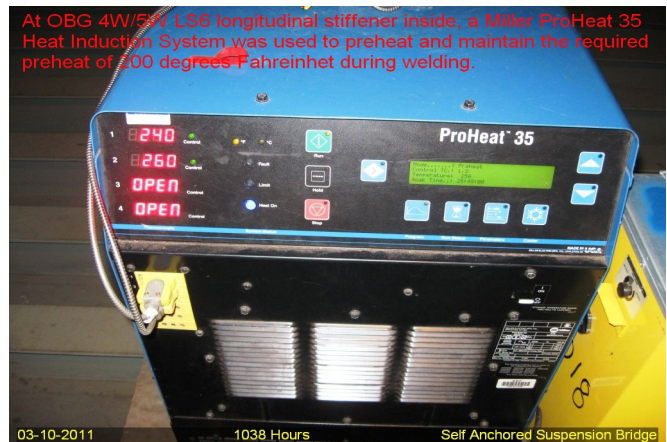
At OBG 9W/10W side plate 'E2'(2640mm to 4680mm) inside, QA randomly observed ABF/JV qualified welder Sungtao, Huang ID # 3794 continuing to perform CJP groove (splice) welding fill pass to cover pass on the splice butt. The welder was observed perform manually welding in the 3G (vertical) position utilizing a Shielded Metal Arc Welding (SMAW) with 1/8" diameter E7018H4R electrode and implementing Caltrans approved Welding Procedure Specification (WPS) ABF-WPS-D15-1040B . The joint being welded has a single V-groove butt joint with backing bar. The splice joint was preheated with propane gas torch prior welding. During welding, ABF Quality Control (QC) Steve Jensen was noted monitoring the welding parameters of the welder. At the end of the shift, cover pass welding was completed.

At OBG 4W/5W LS6 longitudinal stiffener inside, QA randomly observed ABF welder Xiao Jian Wan ID #9677 perform 3G (vertical) Shielded Metal Arc Welding (SMAW) complete joint penetration (CJP) welding fill pass on the stiffener splice butt joint. The stiffener plates being welded are made of high strength plate material HPS 485W and has a thickness of 30mm. The joint has a double V joint preparation that was welded from one side and after the completion from one, side to be back gouged; Non Destructive Testing (NDT) tested using Magnetic Particle Testing (MT) and back welded to the other side. Prior welding, the fit up was inspected and accepted by ABF QC Gary Ersham. QA also verified the root gap of less than 8mm and alignment of less than 2mm which deemed acceptable to the contract requirements. The welder was noted using E9018H4R with 1/8" diameter electrode

QA randomly observed ABF/JV qualified welder Rory Hogan continuing to perform CJP groove (splice) back welding cover pass on Orthotropic Box Girder (OBG) 9E/10E side plate 'C' outside. The welder was observed back welding in the 4G (overhead) position utilizing a dual shield Flux Cored Arc Welding (FCAW-G) with E71T-1M, 1/16" diameter wire electrode and implementing Caltrans approved Welding Procedure Specification (WPS) ABF-WPS-D15-3110-4. The welder was using a track mounted welder holder assembly that was remotely controlled. The joint being welded has the backing bar gouged using the Esab Plasma Arc machine and was ground smooth. The gouged and ground splice butt joint was also Non Destructive Testing (NDT) tested using the Magnetic Particle Testing (MT). The splice joint was preheated and maintained to greater than 150 degrees Fahrenheit using Miller Proheat 35 Induction Heating System located on top of the plate prior welding and by moving the blanket to the side of the weld being welded during welding. The vicinity was also properly protected from wind and other climatic conditions. ABF Quality Control (QC) Steve Jensen was noted monitoring the welding parameters of the welder. At the end of the shift, fill pass welding was still continuing and should remain tomorrow.

At OBG 10E/11E edge plate 'B' outside/inside, QA randomly observed ABF/JV qualified welder Fred Kaddu continuing to perform back welding fill pass on the Complete Joint Penetration (CJP) splice butt joint. The welder was observed manually welding in the 3G (vertical) position utilizing a Shielded Metal Arc Welding (SMAW) with 1/8" diameter E7018H4R electrode and implementing Caltrans approved Welding Procedure Specification (WPS) ABF-WPS-D15-1040B. The joint being welded has a single V-groove butt joint with steel backing bar that has been back gouged. ABF Quality Control (QC) John Pagliero was noted monitoring the welding parameters of the welder. QA randomly monitored the welding parameter with reading of 130 amperes which appears in conformance to the contract requirements. During the shift, SMAW cover pass welding was completed and the welder has moved inside and carbon arc the backing bar removal. The backing bar removal was completed and so with its smooth grinding. ABF QC John Pagliero performed the Magnetic Particle Testing (MT) of the backing bar removal and after its completion the welder started back welding fill pass on the butt joint. At the end of the shift, fill pass welding was still continuing and should remain tomorrow.

At the request of Quality Control Field Supervisor, Bonifacio Daquinag, QA has randomly verified the QC MT of the Complete Joint Penetration (CJP) welding of two longitudinal and one transverse stiffener butt joints. The QA verification was performed to verify that the welding and the MT inspection performed by the QC inspector meet the requirements of the contract documents. At the conclusion of the QA verification it appeared that the welds and the QC inspection complied with the contract documents.
